**MILFORD TOWN DAM**

**NH 00312**

**PHASE I INSPECTION REPORT  
NATIONAL DAM INSPECTION PROGRAM**

**APRIL 1979**

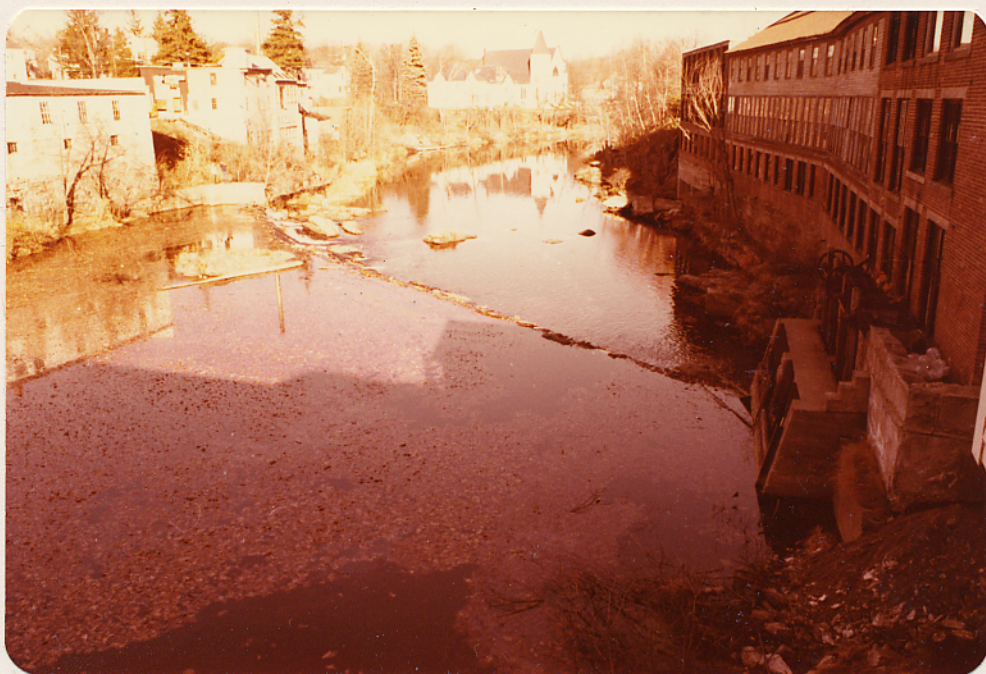
Overview of dam from upstream road bridge

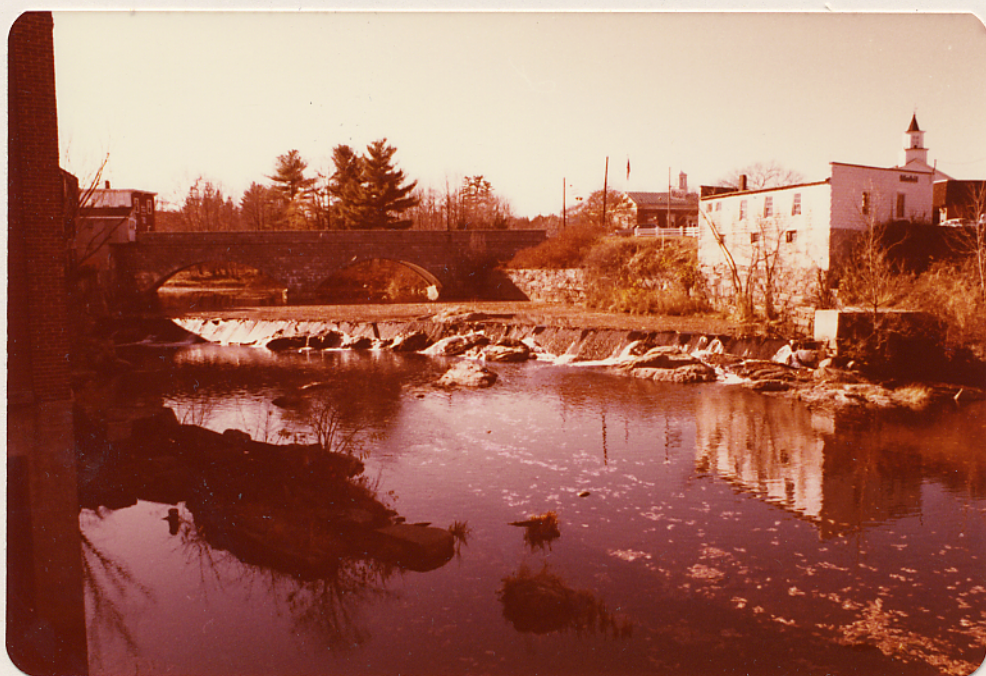
Overview of dam from right side of downstream channel

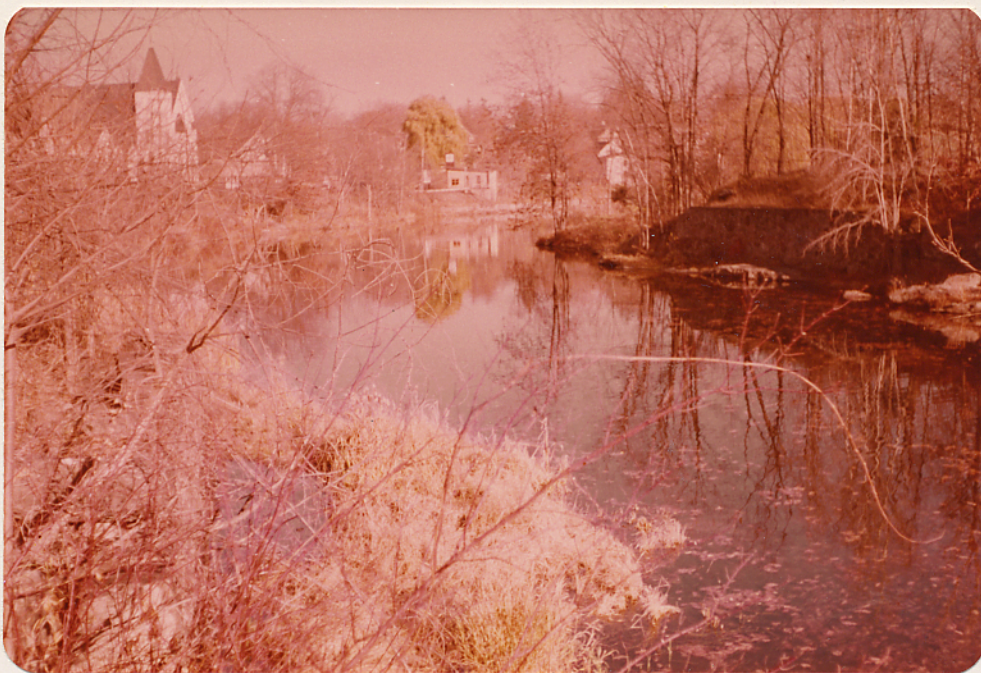
1. View of downstream channel from left abutment

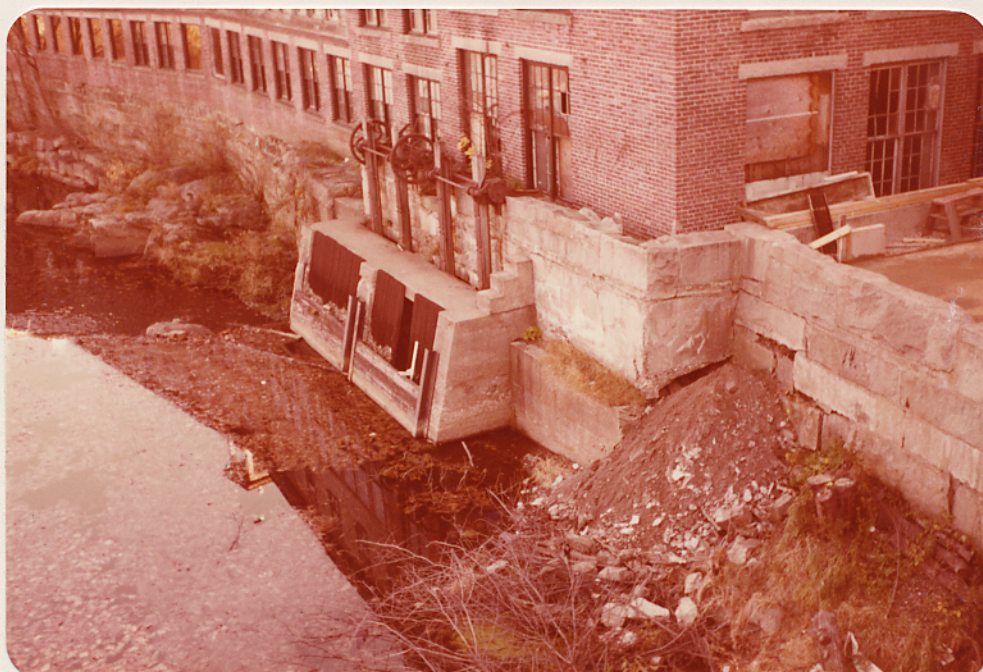
The stone masonry wall adjacent to the intake structure (Photo 2) is founded on a 10 foot long concrete foundation. The concrete is eroded over the entire interface with the cemented stone masonry wall. This erosion is up to 12 inches deep. Approximately 10 feet of the adjacent upstream wall has been undermined and settled. Stepped cracks up to 3 inches high are visible. Random fill has been placed in front of the wall. The remainder of the wall does not show any evidence of displaced stones, bulges, or other signs of distress. The mortared joints are effloresced.

The concrete (Photo 2) located between the right intake structure and the cemented stone masonry wall has a series of horizontal cracks and is effloresced. The cracks are located about 5 feet above the spillway crest. The downstream continuation of the wall is approximately 15 feet high and serves as the building foundation wall. The wall is in good condition with no evidence of displaced stones, bulges, or other signs of distress. The mortared joints are effloresced.

2. View from upstream road bridge showing abandoned inlet structure

- (3) Repair the concrete on the right upstream training wall.
- (4) Repair the concrete on the right downstream training wall.
- (5) Remove trees and other brush growing between the two downstream training walls.
- (6) Institute a program of annual technical inspections.

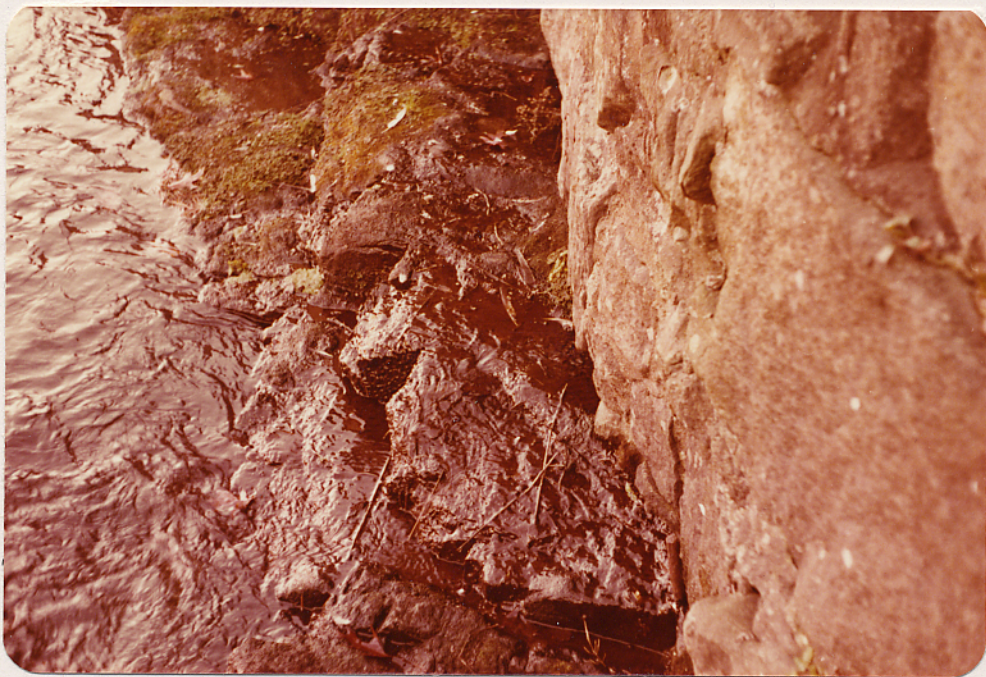
| AREA EVALUATED | BY | CONDITION & REMARKS |
|---|---|---|
| Seepage | NAC | Under foundation of old mill building 8 feet downstream of the spillway at the rate of 4 to 8 gpm |

3. View from gate structure of seepage between bedrock and old mill building wall

- (1) Repair the deteriorated concrete on the right intake structure.
- (2) Monitor by visual observation the seepage at the base of the intake structure and building for changes in flow quantity or turbidity which may require remedial action.

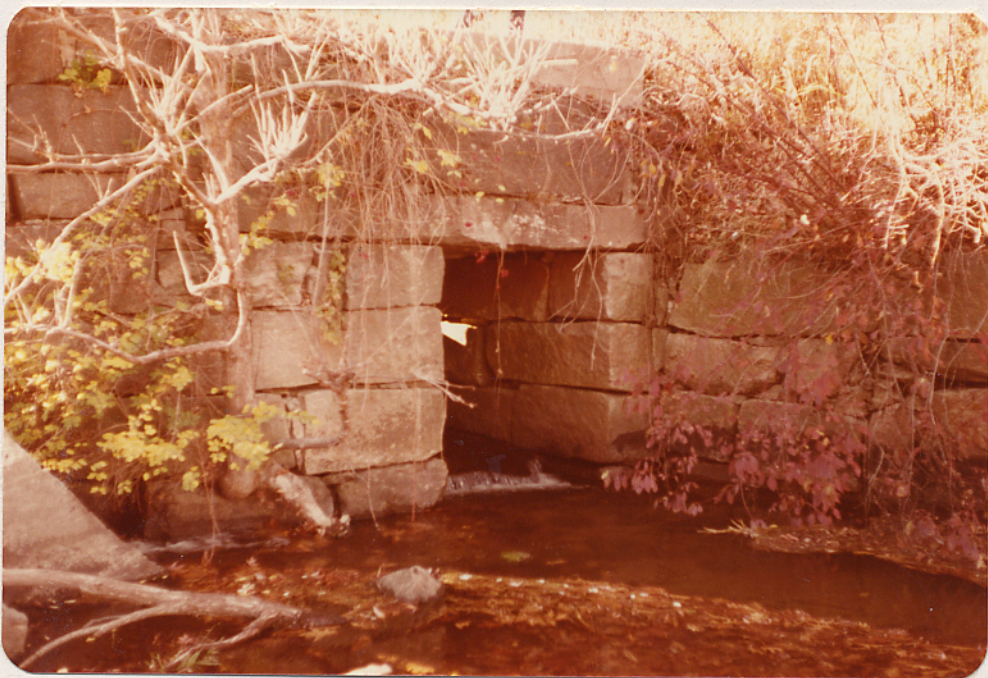
4. View of sluiceway from downstream channel

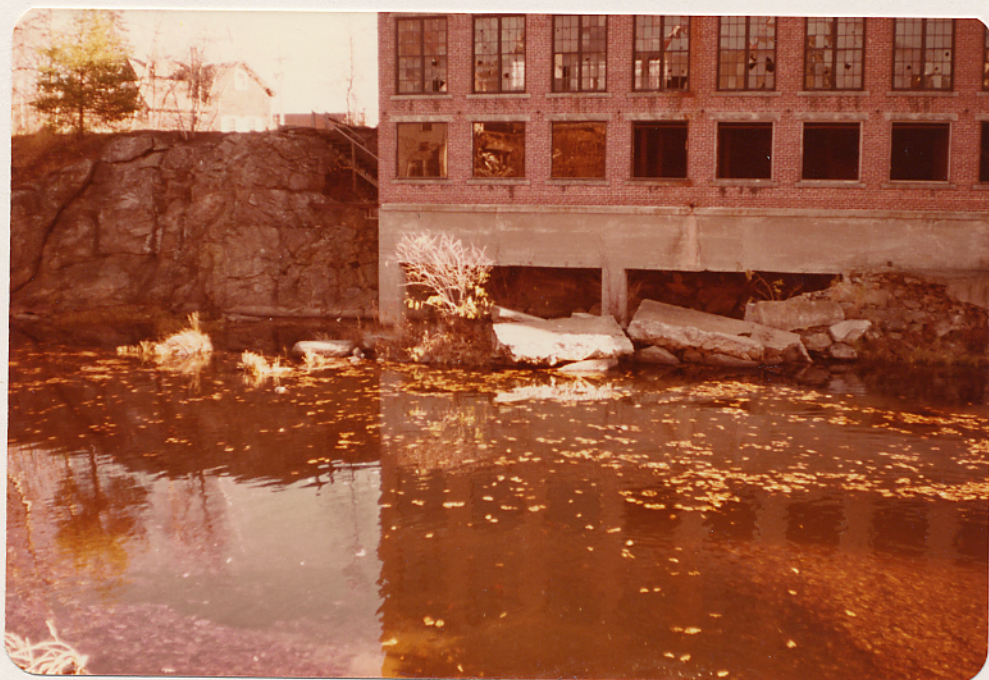
5. View of old mill building from left abutment showing old discharge channel from power plant in building

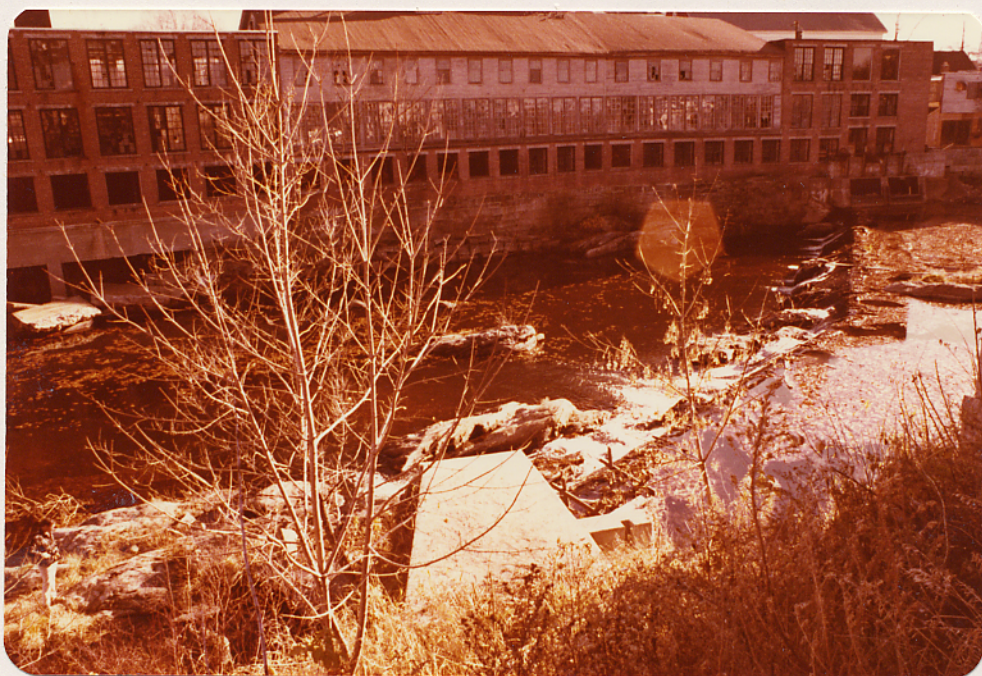
6. Overview of dam from left abutment
